Project No.
S25058

***Geotechnical Site Investigation Report
For***

السادة وزارة الأشغال العامة والإسكان
مشروع دراسة جيوتقنية لدراسة أسباب الانهيارات و الهبوط المتكرر
الطريق الملوكي
ذبيان - الموجب

Subject : *Geotechnical Site Investigation Report*
Subsurface Investigation

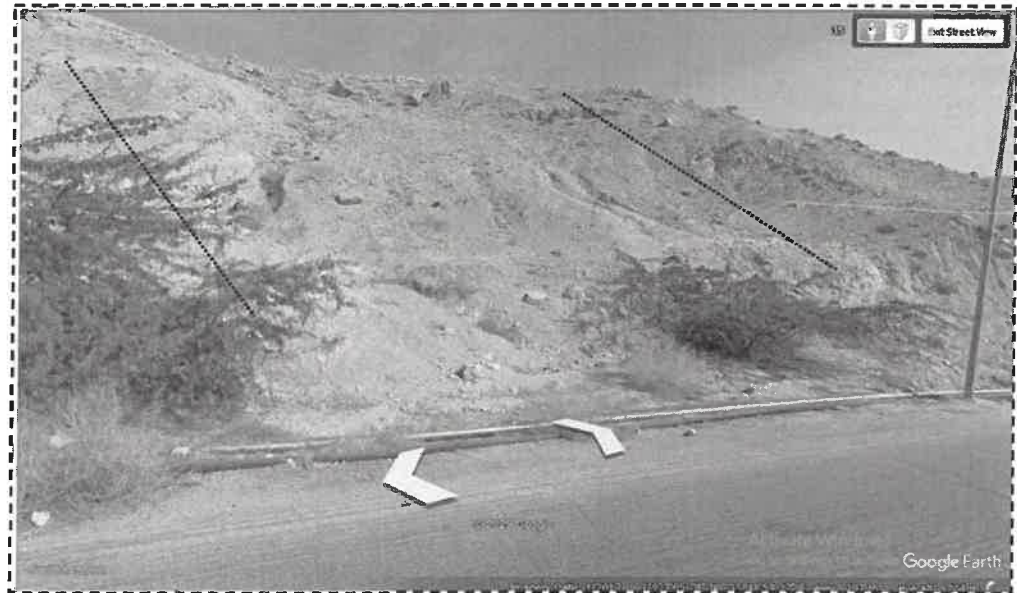
Figure 1

The google map location of the site are attached in figure No.1 and No.2 respectively below.
